Manhole Inspection Summary

Manhole # S61I__027MH

Insp Date: **3/24/08 11:28 AM**

Location Address: **501 Rappolla St.**

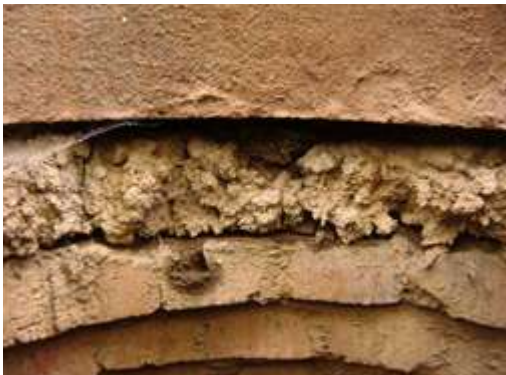
Defect 2

Infiltration: ☐ None ☒ Joint ☐ Cracks ☒ Mortar ☐ Roots ☐ Wall

infiltration at frame joint

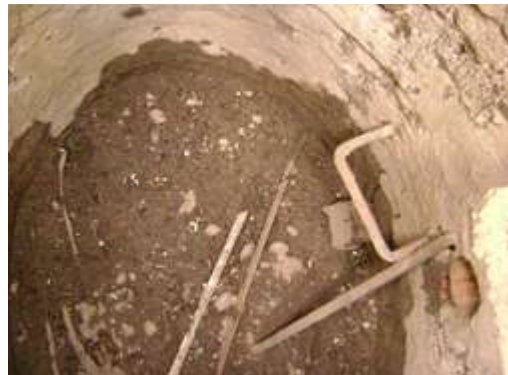
Defect 3

Infiltration: ☐ None ☐ Joint ☐ Cracks ☒ Mortar ☐ Roots ☒ Wall

Condition: ☐ Sound ☐ Cracked ☐ Root Intrusion ☐ Deteriorated ☐ Leaks ☒ Debris

infiltration from barrel and debris on bench

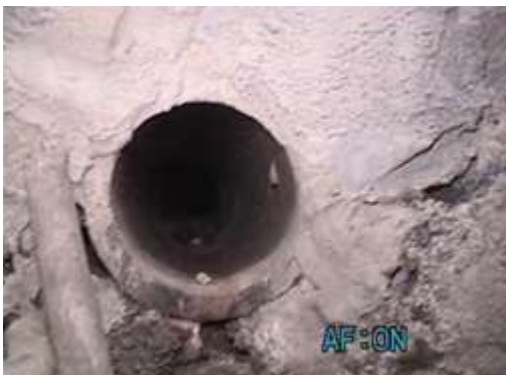
Defect 5

Cracked pipe seal 8:00-9:00 incoming 9 O'Clock

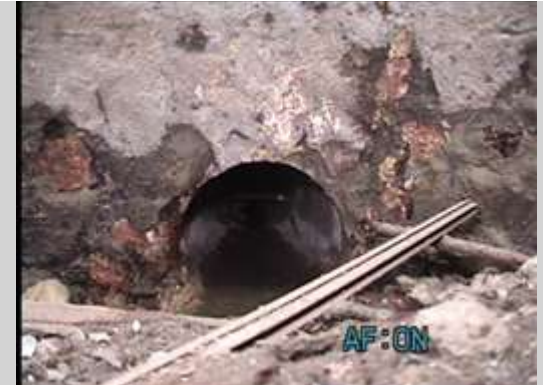
12 O'Clock Outflow

8 in. Circular Gravity Sewer
Pipe Out @ 12 O'Clock

Infiltration: **None** Pipe Seal Cond: **Sound**

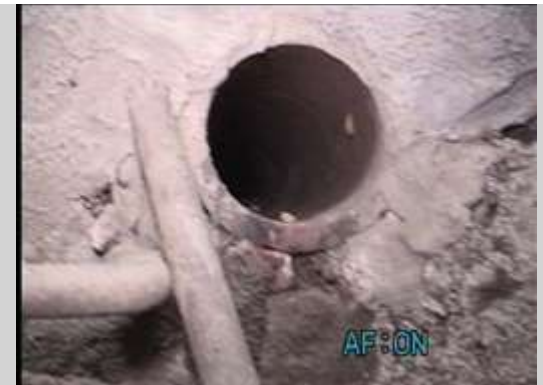
9 O'Clock Inflow

4 in. Circular Gravity Sewer
Pipe In @ 9 O'Clock

Infiltration: **None** Pipe Seal Cond: **Cracked**
